**UP-DATE TO THE EVALUATION OVER ARCHAEOLOGICAL SITE FROM
PRAVETS/BOROVETS**

It was made a new evaluation over the archeological site from BOROVETS, also an interesting meeting with the general manager from PRAVETS historical museum from there, to fix few un-cleared problems about the site.

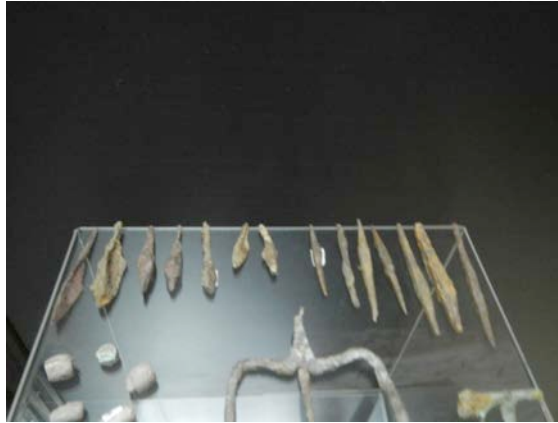
Because we try to identify the correct period of the site, we are making together a short study over the arrows-heads discovered in the area of the site, in/outside of it, as:

All the arrows-heads are ancient roman type,made by iron and-what is strange for us-are *different types of them,NOT the same...*

This fact,toghether with *the roman structure of the walls,*also with *the conection made between the ancient fortress and others form defensive links* from Balcans(are already known 12 locatioons like this!),give us the right to say that the archaeological site form BOROSETS is roman,in principal part of it.

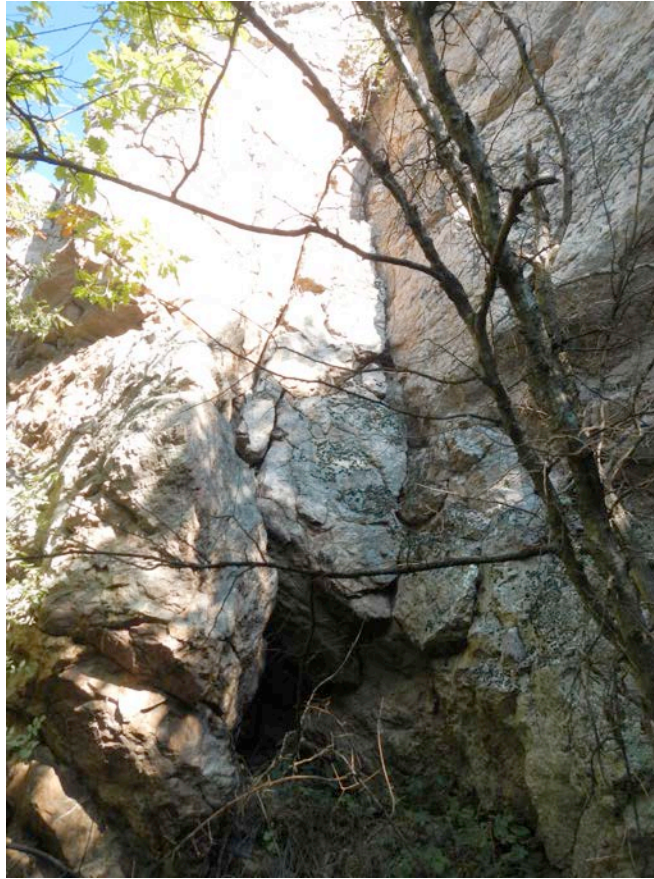
3.a. GPS point at = 42.94510N 023.87997E, alt= 660m;

CAVE DIMENSIONS= 110 cm hight,100 cm large,about 200 cm deep;

As ALL small caves founded in the are are made by crashed stone,like a “cake’cutted in there parts,from which the middle one falls down like a “ghylotine”closing the entrance as aking of natural “door”,but is nothing behind it.

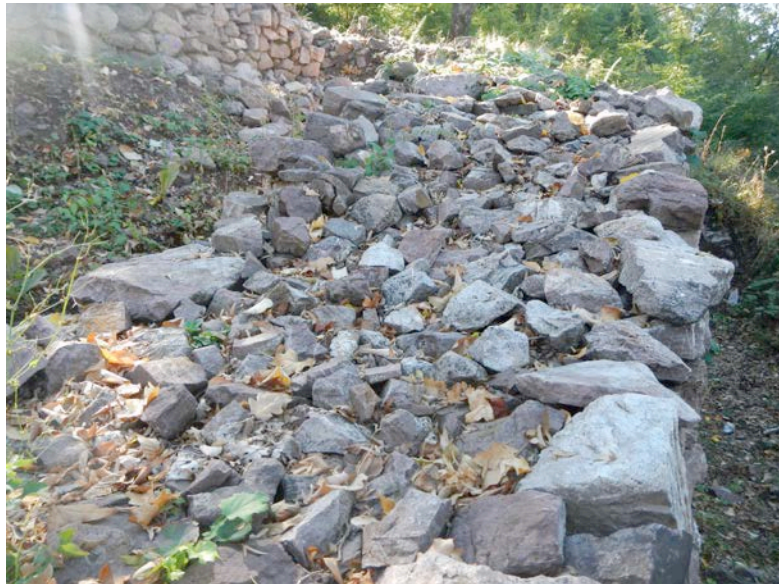
4.a. The structure of the walls are typically roman,with two external sides of it,maed by huge stones,and with a lot of small stones in the middle,fixed by mold:

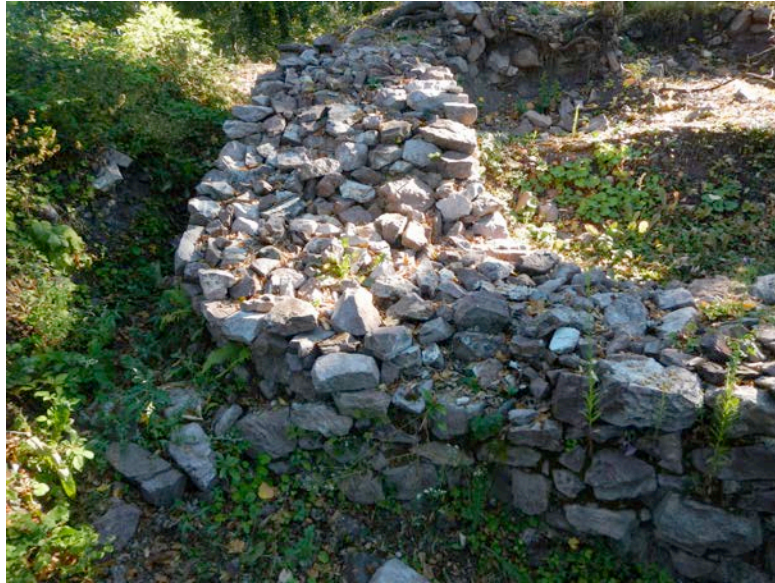
4.b. the "ROUND CORNER" is just like this(ROUND!!!),and the stones by which is made are fixed with mold,so is *NO way to be a bad reconstruction of it, made by the specialists,or for other reasons.*

Also is NO chance to be made for a reason as to make ...economies!!! (this section is larger than the others,so-where is the economy of materials?)

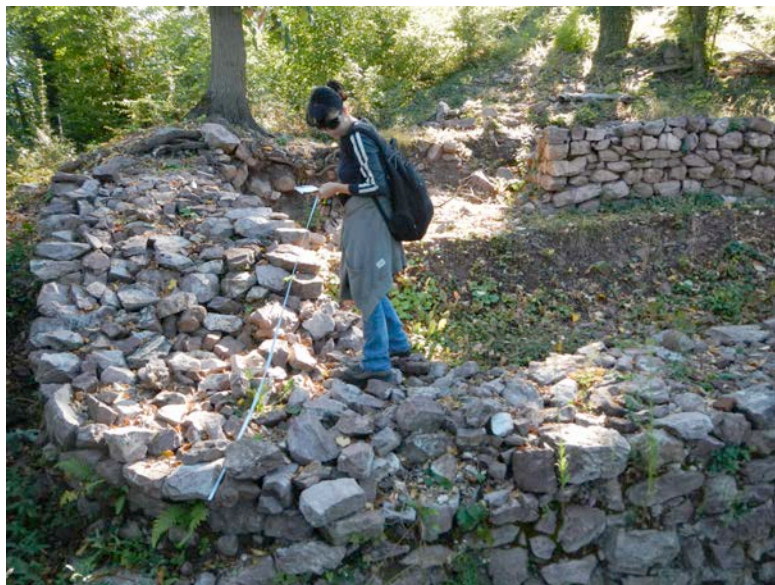
Also, measurement of it, made by us, from the upper part of the wall (where the tree is), to down part of it, in section, from 2 to 2 meters, showing a start point large about 130 cm, than 140 cm, than 200 cm (just where the round segment is!), than 150 cm and –finally– 160 cm, which shows that the “round corner” was larger than the rest of the wall, maybe to fix better the resistance of the structure.

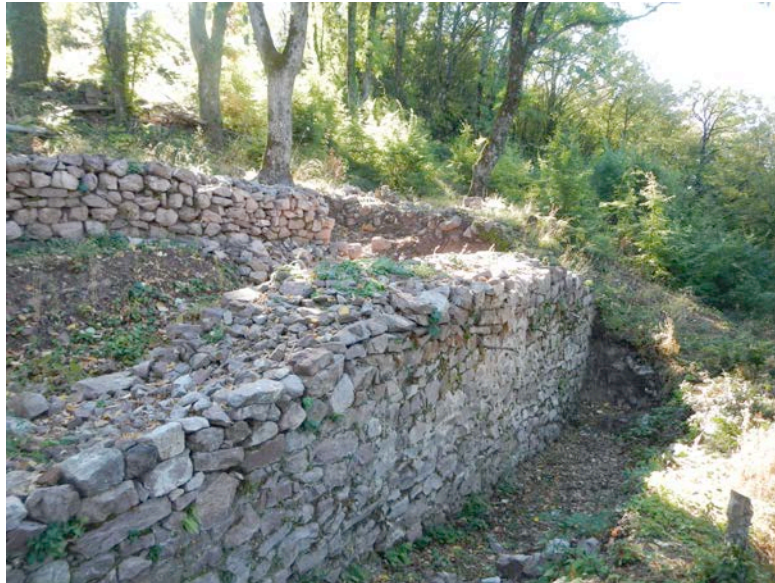
5. Speaking about the “holles” made inside the external defensive wall, to escape from rain waters(?), those are not penetrating the stone wall, and seems to be made just for a wooden structure (console?), to support a wooden external structure (still we believe that those “holles” and the “round corner” also, show the place for the main gate, just nearby of them, being a possibility for the western branch of the roman road to follow the western line of the external walls until the main gate of the fortress).

Beside the holes are not passing thru the wall structure,those are too high placed to be useful to escape from rain waters from inside the fortress.
